Frontal Side Swipe Collisions

MARC1 SOLUTIONS

Rudy Limpert

Short Paper PCB1 – 2014

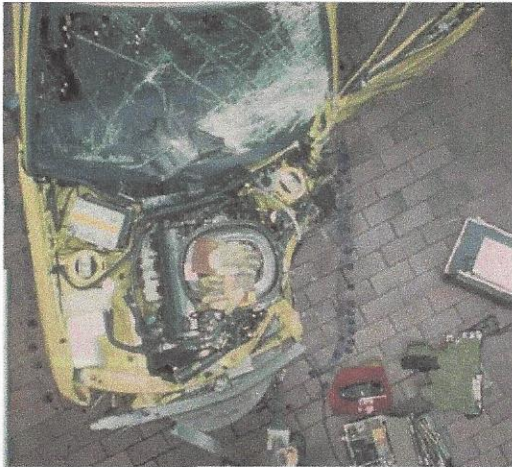
EES von Fahrzeug 1 für den Mercedes-Benz-Pkw-Baureihe 201 wurde mit 48 km/h ermittelt.

The crush data, such as A and B stiffness coefficients, crush width and crush depth were chosen to obtain the identical EES speeds as specified by Mercedes engineers. The German text at the bottom of page 106 indicates that the EES values were obtained with the help of the deformation photographs. The exactness of the numbers such as 48.00 km/h (29.83 mph) and 42.00 km/h (26.10 mph) might be questioned. A reasonable range of +/- 3 km/h or greater should probably be assigned to each value.

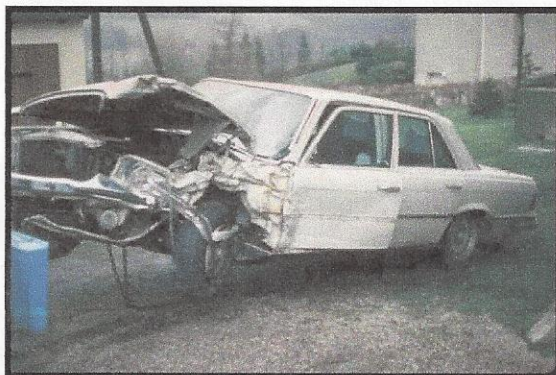
EES von Fahrzeug 2 für den Mercedes-Benz-Baureihe 116 wurde mit 40 km/h ermittelt.
